Manhole Inspection Summary

Manhole # S29MM1007MH

Location Address: **4419 LINKWOOD RD**

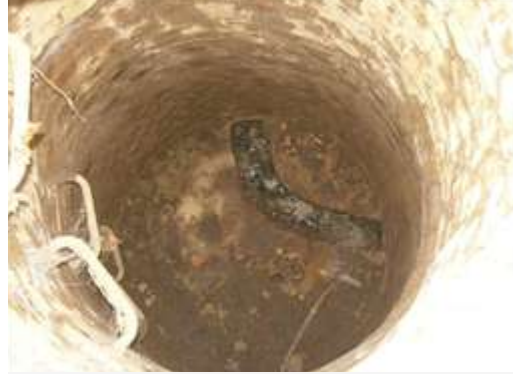
Top View

Evidence of surcharge - Bench debris.
Channel debris.

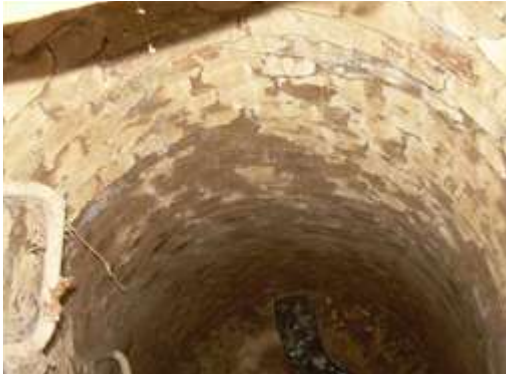
Defect

Condition: ☐ Sound ☐ Cracked ☐ Root Intrusion ☐ Loose Brick ☒ **Deteriorated**

Infiltration: ☐ None ☒ **Joint** ☐ Cracks ☒ **Mortar** ☐ Roots ☐ Wall

Corbel deterioration and infiltration. Barrel infiltration.

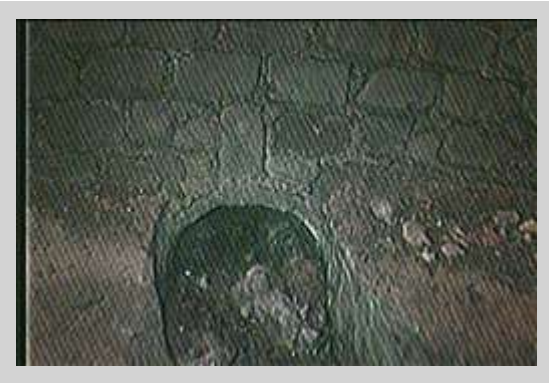
6 in. Circular Gravity Sewer Pipe Out @ 12 O'Clock

Barrel deterioration and infiltration.

Deposits: ☐ None ☒ **Mud** ☐ Sludge ☒ **Debris** ☐ Grease

Silt Depth: **4** (in.) Deposits Extent: **Heavy**

Infiltration: **Evidence** Pipe Seal Cond: **Cracked**

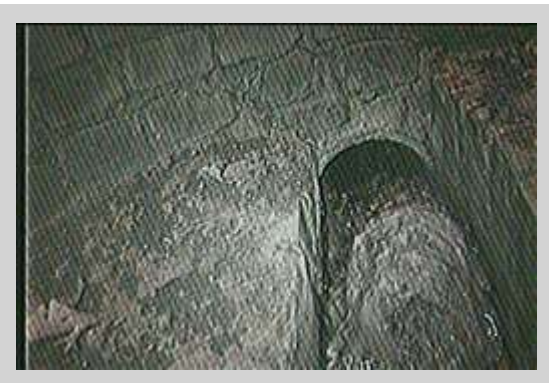
6 in. Circular Gravity Sewer Pipe In @ 3 O'Clock

Deposits: ☐ None ☒ **Mud** ☐ Sludge ☒ **Debris** ☐ Grease

Silt Depth: **3** (in.) Deposits Extent: **Medium**
